# Daily Report

## Sheridan County Brooks Street Greenspace

224 South Main Street  
Sheridan, WY 82801  
Job# : 6017.002.00

### WATER SERVICE

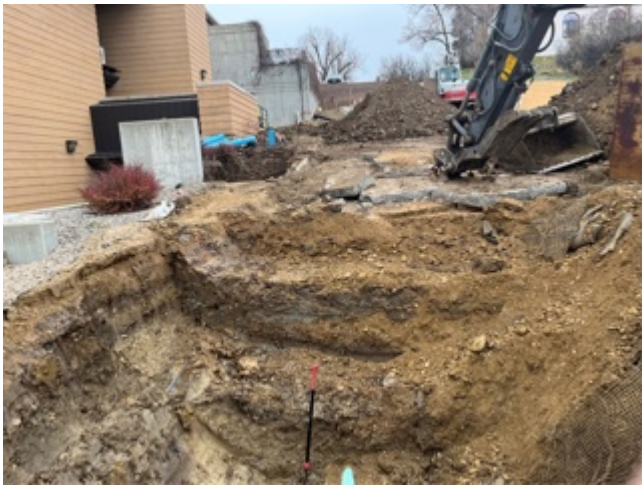
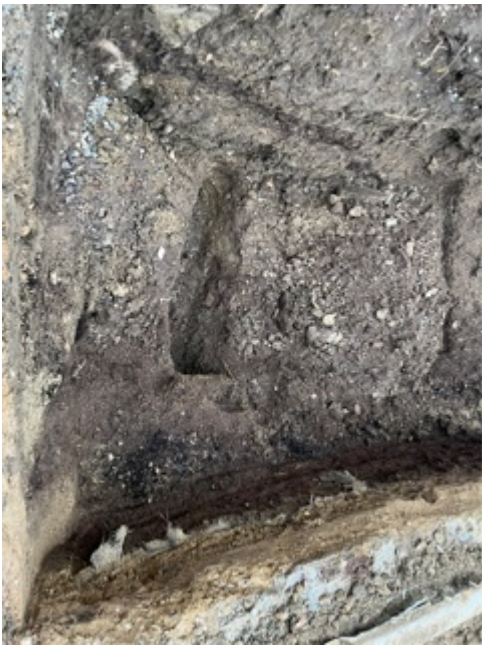
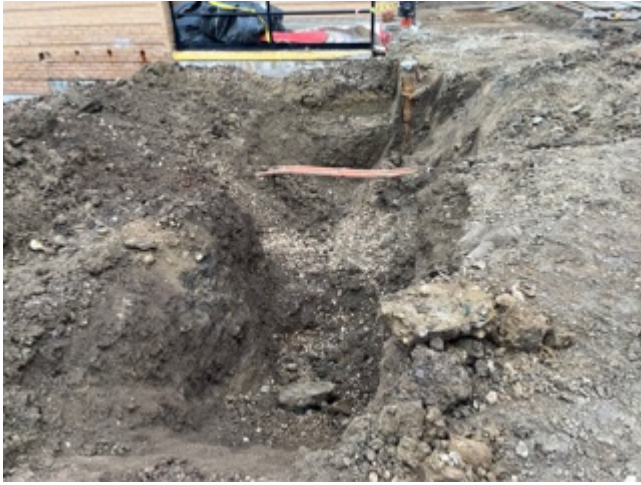
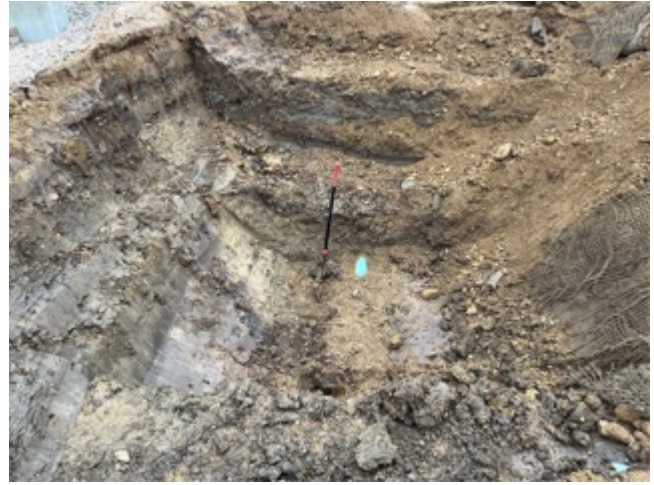
02:50 PM **Tre LaBossiere**  
[Lat/Long: 44.795310,-106.957592]  
Arrived on site at 2:45. Northern Underground was not on site and no work was in progress.

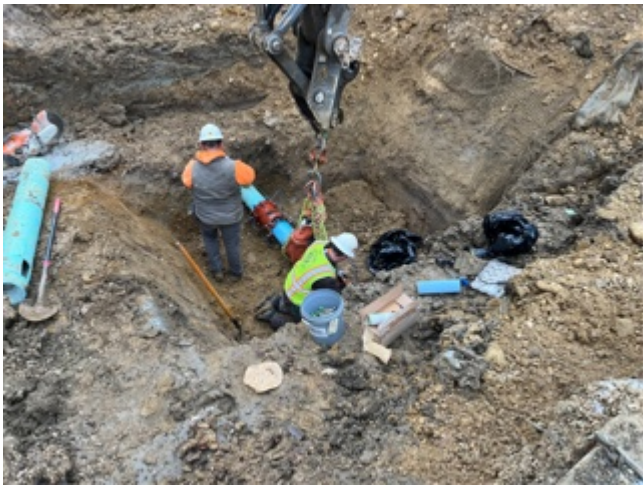
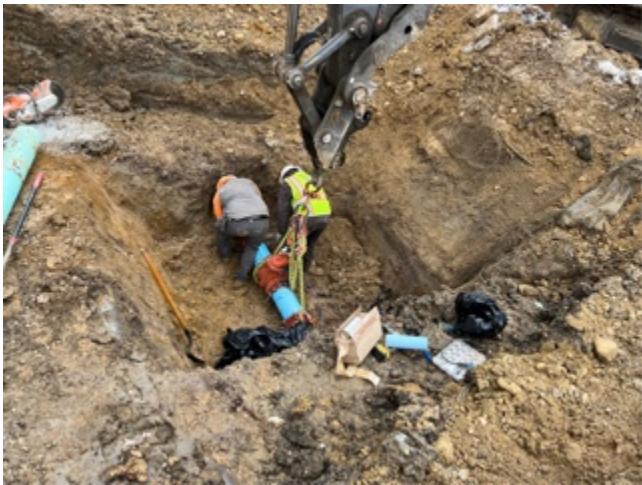
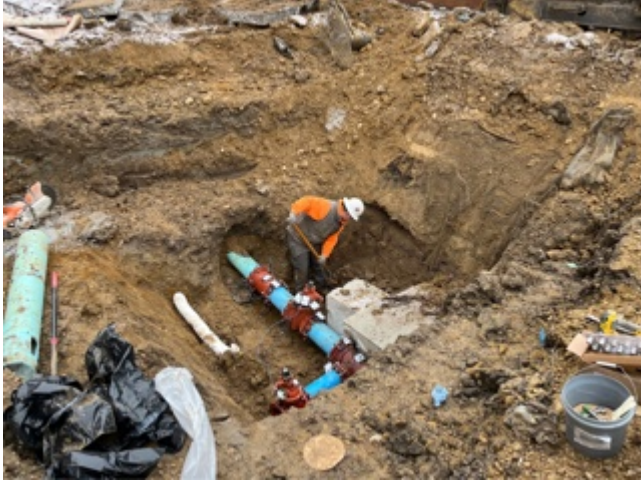
NU was in the process of connecting the water lines at STA 0+03 using a mainline valve and a tee. While on-site I witnessed NU place the tee, valves, and bolt the fittings up to the existing line. Inspecting from the top of the trench it appeared that NU was using adequate bedding above and below the pipe (>6" required by City of Sheridan Standard Specifications) and that the water was laid more than 6' underground. NU monitored the bury depth of the water line by using a tape measure from the top of the water line to the top of the trench. NU was also using a jumping jack to compact the bedding material along the side of the water pipe.

No backfilling and compacting was happening while I was on site.

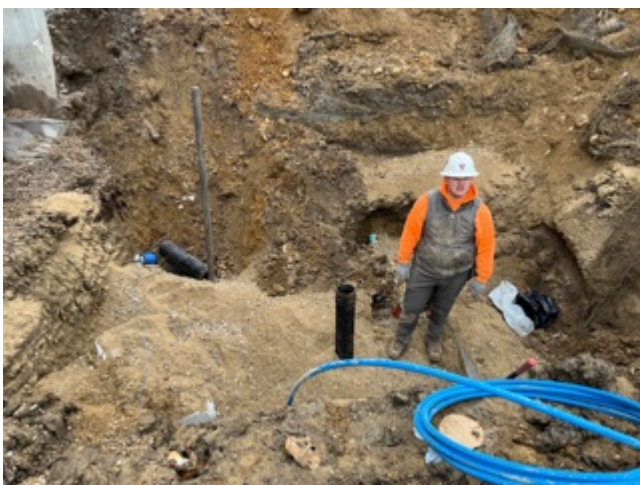
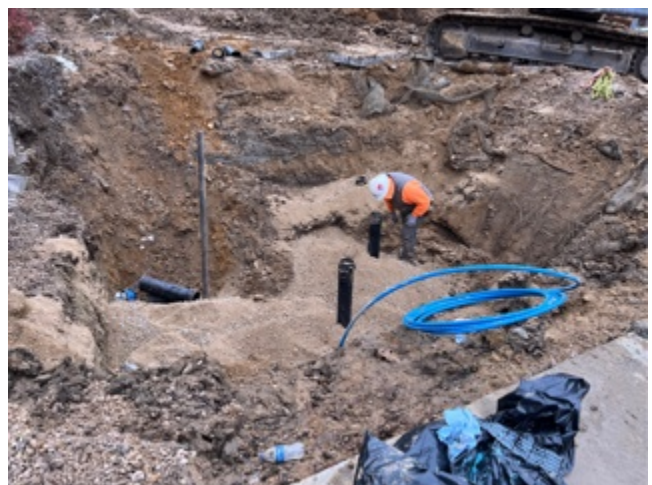
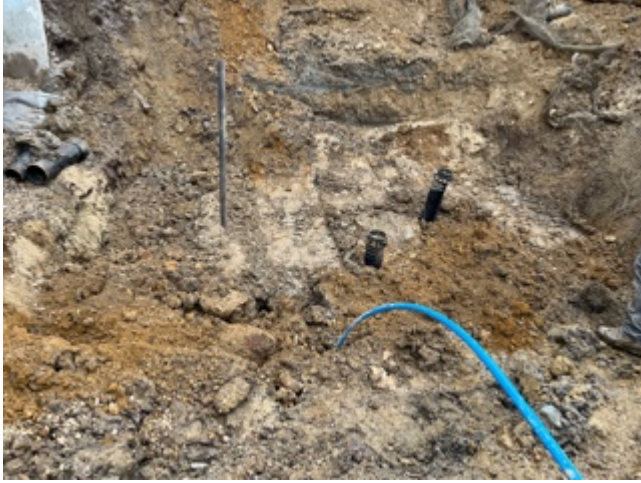
NU was in the process of placing a bend at STA 0+12. While on-site I witnessed NU place the 90-degree bend, the thrust block behind the bend, start to place bedding, and backfill. Inspecting from the top of the trench it appeared that NU was using adequate bedding above and below the pipe (>6" required by City of Sheridan Standard Specifications) and that the water was laid more than 6' underground. NU monitored the bury depth of the water line by using a tape measure from the top of the water line to the top of the trench. NU was also using a jumping jack to compact the bedding material along the side of the water pipe.

The backfilling and compacting operator made sure to use small lifts (less than 1') of non-compacted material and was working around STA 0+04. While he was compacting he was using approximately the amount of effort to achieve 95% compaction (need a compaction test to verify as it is impossible to gauge compaction by visual inspection). The material that was used to backfill had adequate moisture and was not too dry or over-saturated.

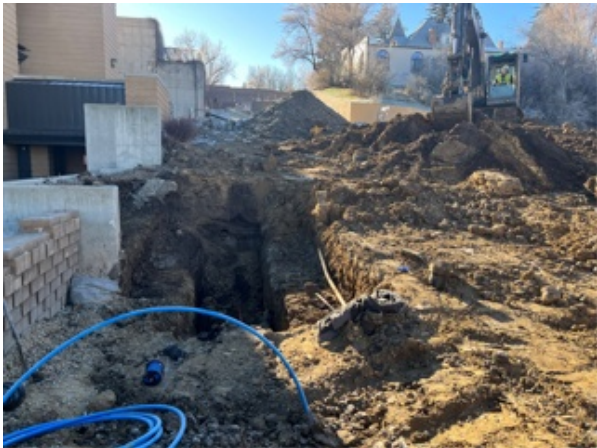
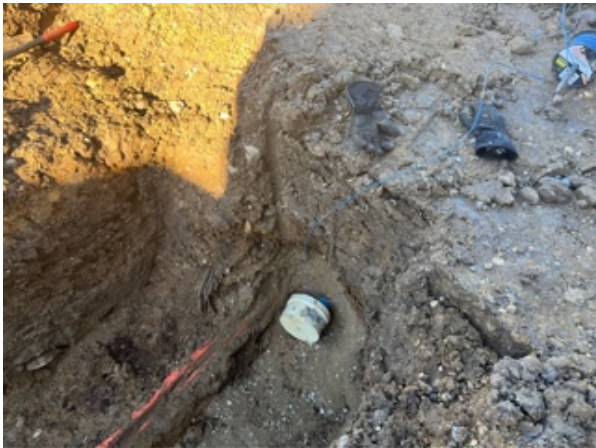
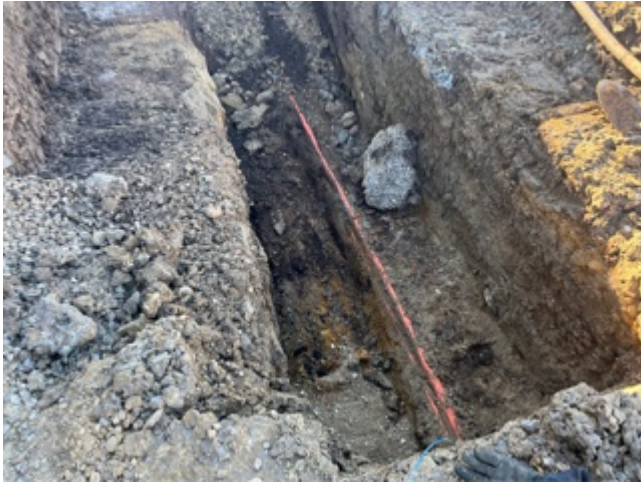
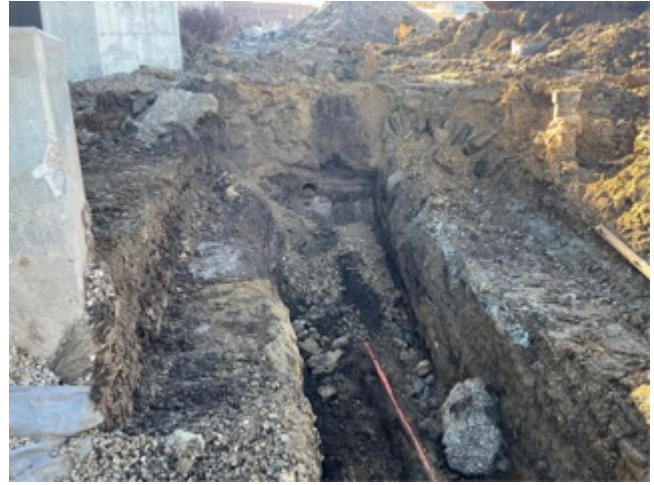
While on-site I witnessed NU place one stick (out of the 90 degree bent at STA 0+12) of waterline and backfill and compact that same stick. Northern Underground did not want to leave an open water line trench so they will place one stick and backfill and compact right after placing it. Inspecting from the top of the trench it appeared that NU was using adequate bedding above and below the pipe (>6" required by City of Sheridan Standard Specifications) and that the water was laid more than 6' underground. NU monitored the bury depth of the water line by using a tape measure from the top of the water line to the top of the trench. NU was also using a jumping jack to compact the bedding material along the side of the water pipe.

The backfilling and compacting operator made sure to use small lifts (less than 1') of non-compacted material and was working around STA 0+20. While he was compacting he was using approximately the amount of effort to achieve 95% compaction (need a compaction test to verify as it is impossible to gauge compaction by visual inspection). The material that was used to backfill had adequate moisture and was not too dry or over-saturated.

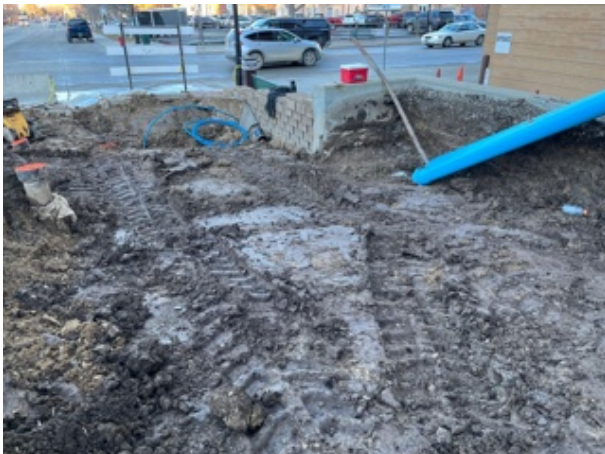
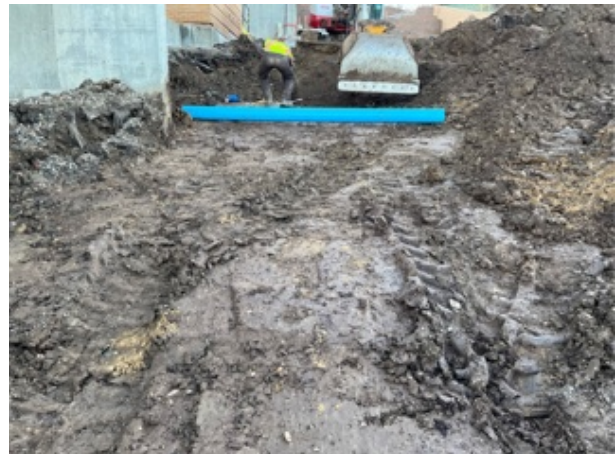
While on-site I witnessed NU place one stick (approx STA 0+40) of waterline and backfill and compact that same stick. Northern Underground did not want to leave an open water line trench so they will place one stick and backfill and compact right after placing it. Inspecting from the top of the trench it appeared that NU was using adequate bedding above and below the pipe (>6" required by City of Sheridan Standard Specifications) and that the water was laid more than 6' underground. NU monitored the bury depth of the water line by using a tape measure from the top of the water line to the top of the trench. NU was also using a jumping jack to compact the bedding material along the side of the water pipe.

The backfilling and compacting operator made sure to use small lifts (less than 1') of non-compacted material and was working around STA 0+30. While he was compacting he was using approximately the amount of effort to achieve 95% compaction (need a compaction test to verify as it is impossible to gauge compaction by visual inspection). The material that was used to backfill had adequate moisture and was not too dry or over-saturated.

Northern Underground also installed and backfilled around the injection corp near STA 0+04.

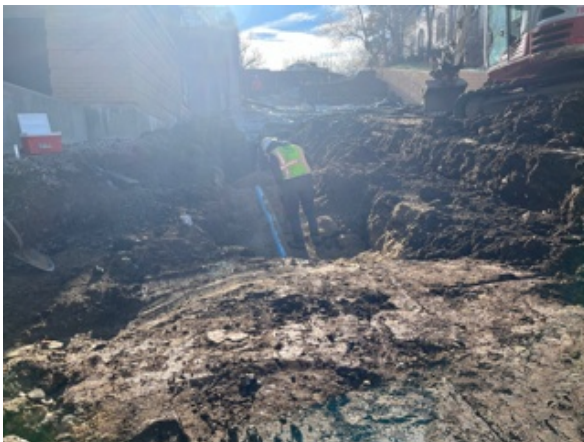
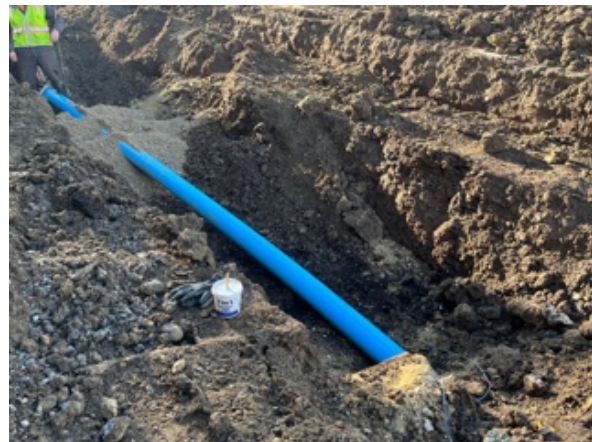
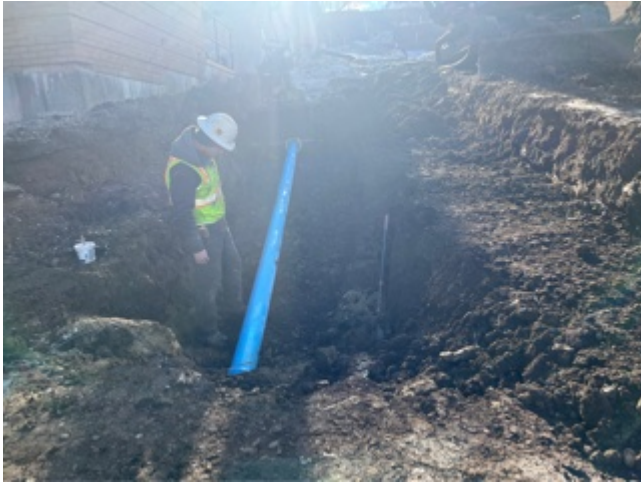
While on-site I witnessed NU place one stick (approx STA 0+60) of waterline and backfill and compact that same stick. Northern Underground did not want to leave an open water line trench so they will place one stick and backfill and compact right after placing it. Inspecting from the top of the trench it appeared that NU was using adequate bedding above and below the pipe (>6" required by City of Sheridan Standard Specifications) and that the water was laid more than 6' underground. NU monitored the bury depth of the water line by using a tape measure from the top of the water line to the top of the trench. NU was also using a jumping jack to compact the bedding material along the side of the water pipe.

The backfilling and compacting operator made sure to use small lifts (less than 1') of non-compacted material and was working around STA 0+50. While he was compacting he was using approximately the amount of effort to achieve 95% compaction (need a compaction test to verify as it is impossible to gauge compaction by visual inspection). The material that was used to backfill had adequate moisture and was not too dry or over-saturated.

I reminded the NU operators to keep track of frozen material not to not throw frozen chunks of dirt in their trench.
