## **Daily Report**

### **Sheridan County Brooks Street Greenspace**

224 South Main Street Sheridan, WY 82801 Job#:6017.002.00

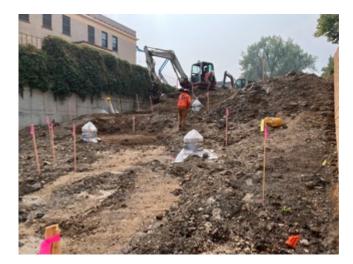
Arrived on site at 11 for the weekly construction meeting. Norther Underground was on site with two laborers removing material to prep the concrete stairs on site. Using the laid out stair wells last week and the GPS units on site Norther Underground was removing the material to the depths noted on the GPS. They were not using survey staking to layout the stair wells.

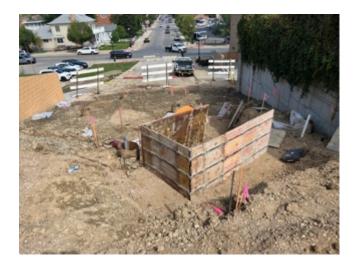
Arrived on site at 3:00. Northern Underground and Stone Mill were on site Stonemill was still placing the forms for the stem walls and hadn't gotten around to placing a bunch of rebar yet. I told Matt that I would check rebar spacing tomorrow as I had measured a few spots in the upper stem wall on site and the spacing was acceptable according to the plans. Matt said he would be out of town tomorrow for the concrete pour.

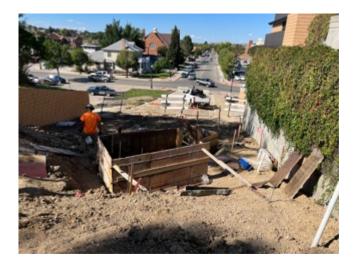
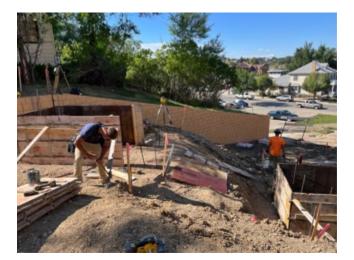
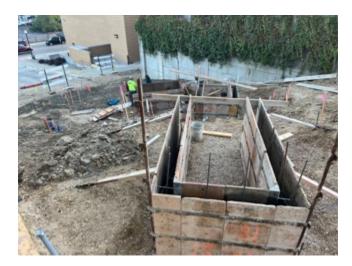
Arrived on site at 7:35. Stone mill was still on site, forming up the lower stem wall for the stairs. I checked the rebar layout for the top two stairwell stem walls, and all the rebar placement was acceptable. The form placement and thicknesses were also acceptable, and according to plans. I re-confirmed with Todd that concrete was going to get poured today at 10 o'clock and he said it was.

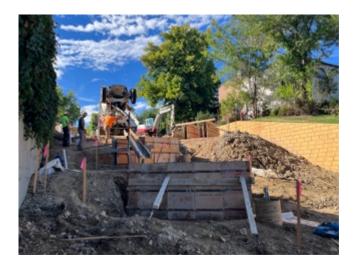
Arrived on site at 10. Stone will start placing concrete right around 1010. Roetech was on site waiting to take concrete samples for the stairwells. There were no issues with the QC of the concrete. Stonemill was using two vibrators to vibrate the concrete once they had the concrete poured into the forms. I told Todd with Stonemill to not vibrate the concrete too much as the middle stairwell was over-vibrated. They were using a hand-built shoot to get concrete down to the third stairwell. They had just finished pouring the middle stairwell when I left the site.
