Daily Report

Sheridan County Brooks Street Greenspace

224 South Main Street
Sheridan, WY 82801
Job# : 6017.002.00

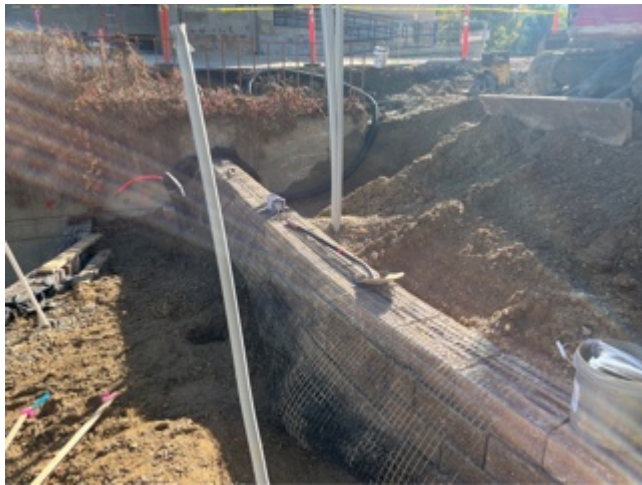
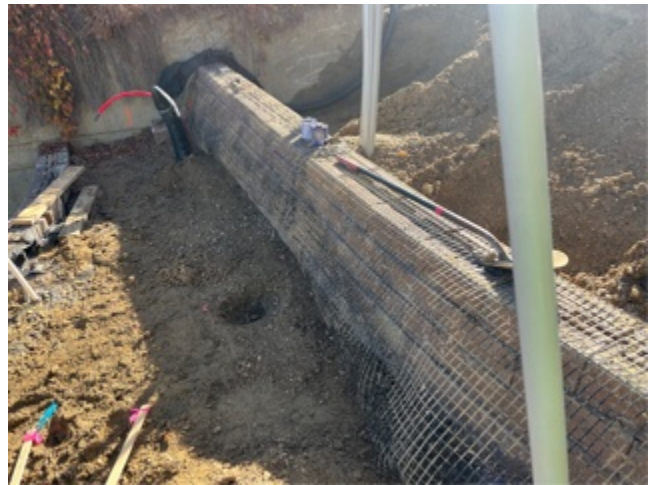
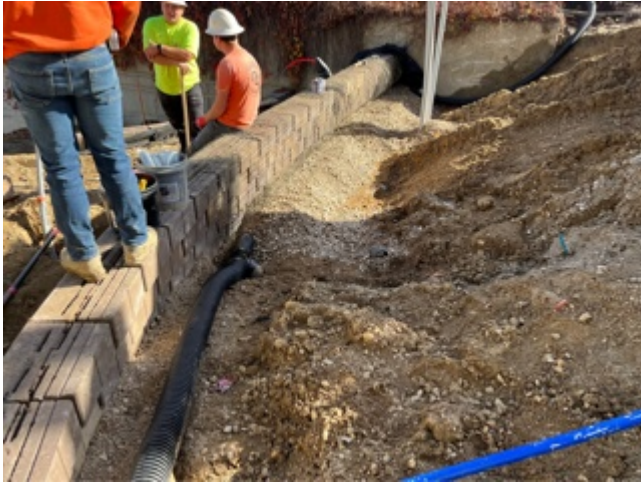
Arrived on site at 10:15. Northern Underground was on site with three laborers. They were in the process of placing the blocks for wall number 12. Northern Underground had placed five rows of blocks for wall number 12. At that point they've already stretched out one layer of Geo grid and secured to the second layer of Geo grid in between the blocks ready to stretch out once they start backfilling behind it. There were no issues with Northern Underground's procedure for placing the blocks, setting the pins, placing the Geo grid, placing the backfill and drainage, rock, and compacting the backfill. While on site, I noticed that Westin mechanical had placed their mechanical sleeves to get behind wall 12 for the heated sidewalk.

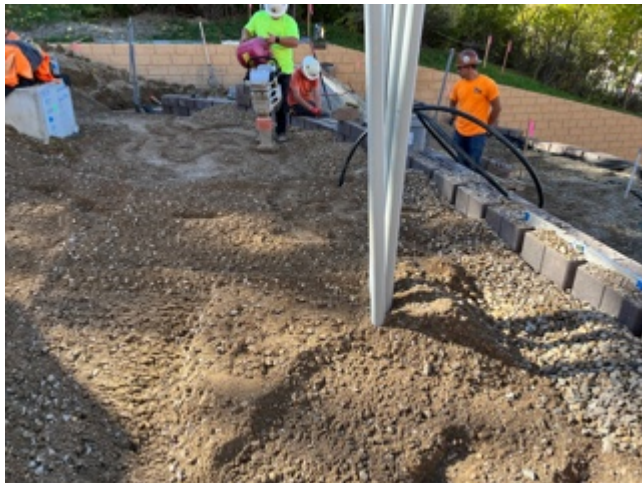
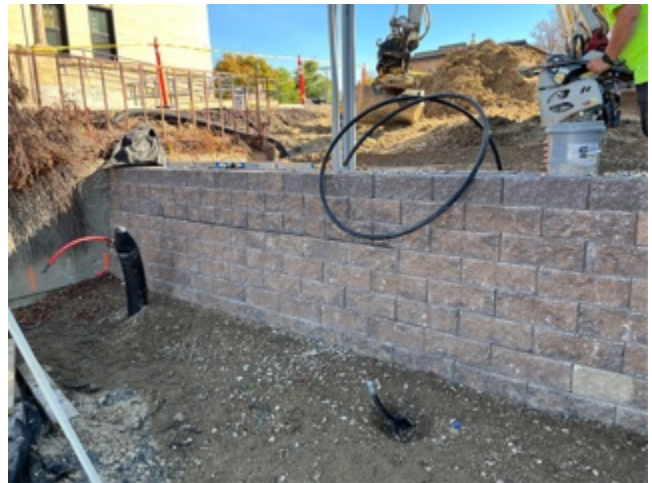
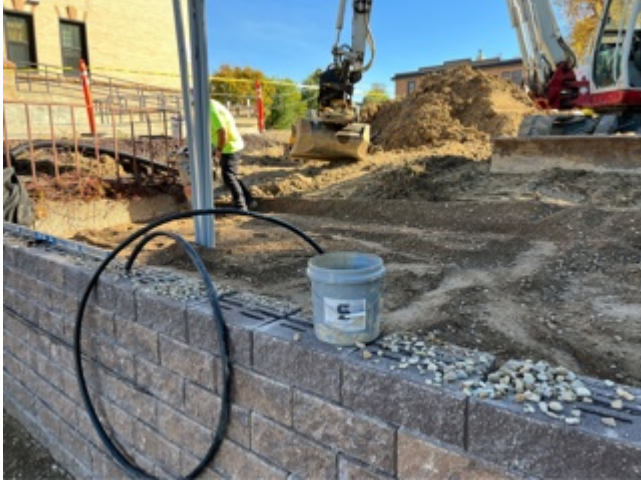
Arrived on site at 2:54. Northern Underground was on site with three laborers. Are the nanograms in the process of placing the top row of blocks on wall 12 and backfilling and placing the drainage, rock immediately behind wall 12. One labor was compacting the engineered fill behind the block wall with a jumping jack. The labor insured to use an adequate amount of efforts to compact the material while compacting lifts that were under 1 foot thick.

Weston mechanical had stubbed up there mechanical sleeves under wall, 12 for the heated sidewalk.

Highland had also stubbed up their irrigation sleeve under wall 12.

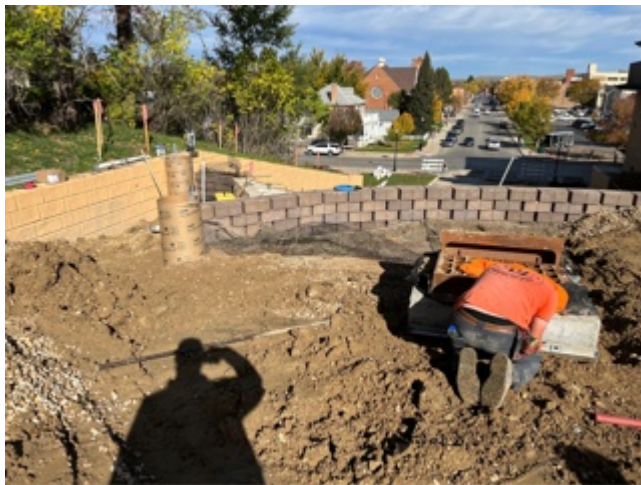
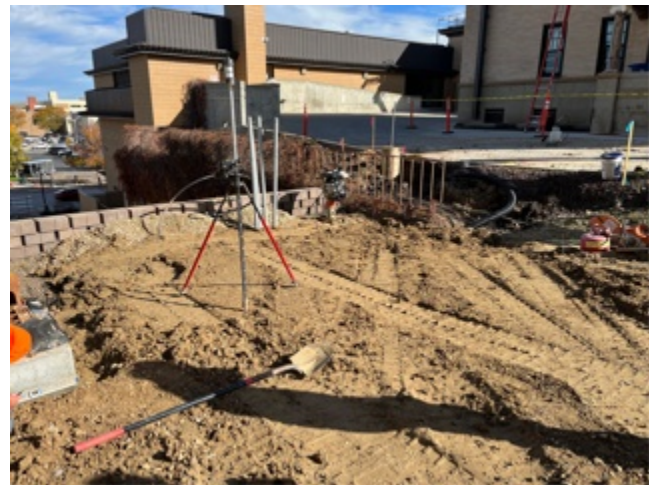
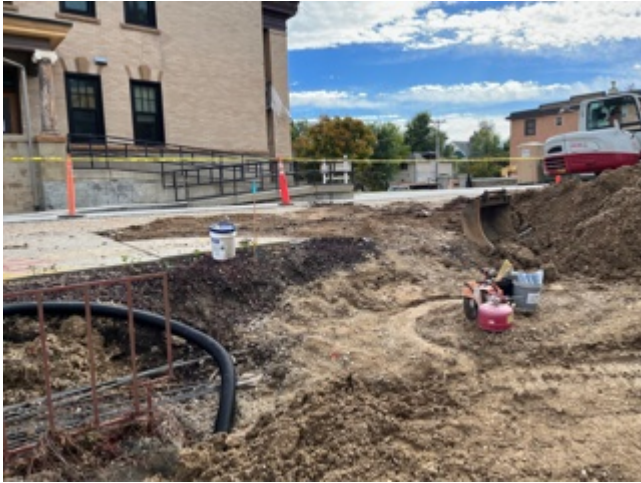
Arrived on site 11 for the weekly construction meeting. Northern underground was on site with two laborers, but not much work was in progress. One laborer was measuring 6 inches down from the top of the curb inlet box. They were afraid they placed the curb inlet box 6 inches too high which would result in the curve hood, being too high in relation to the top back of the curb.

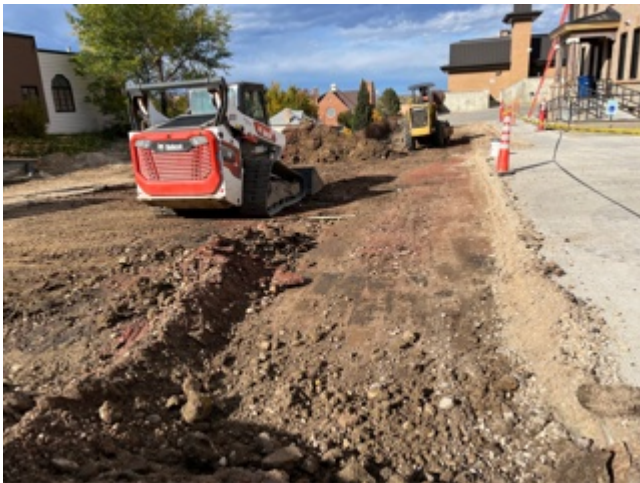
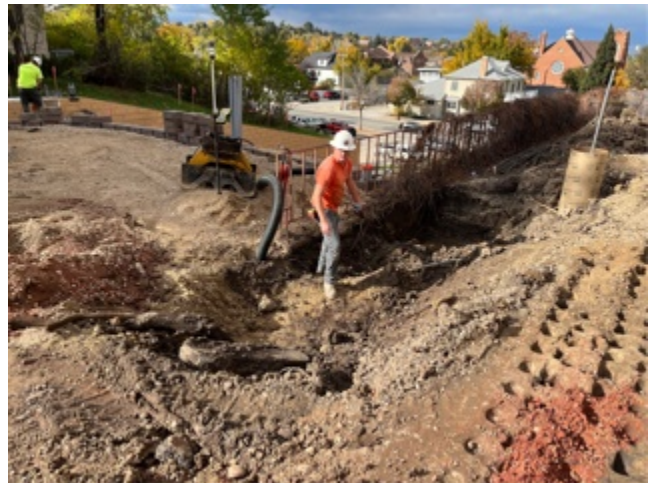
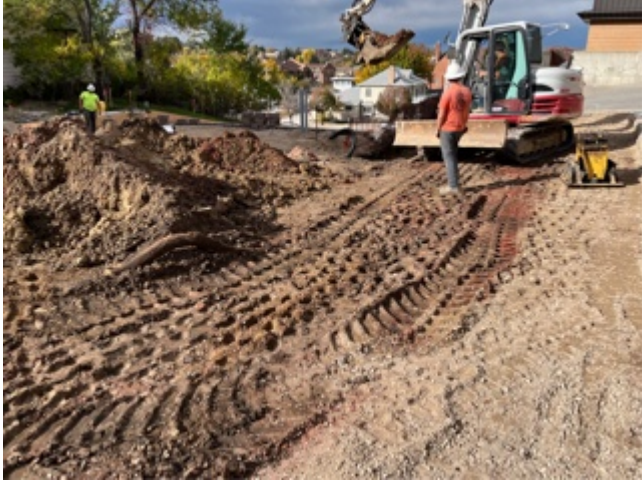
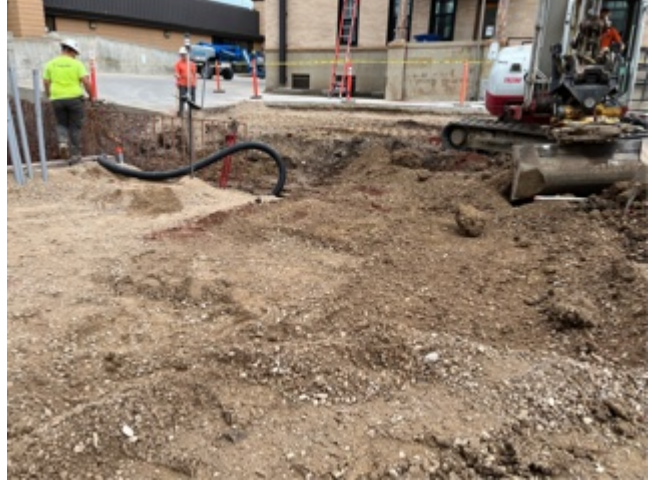
Arrived on site at 2:45. Northern underground was on site with three laborers. Nolan and Randall, are in the process of preparing the subgrade for the upper parking lot across the juvenile justice building. Matt was concerned about some material right near wall 12. He had removed about 5 to 10 yards of material claiming that, they needed to put structural fill in that area. I told him that we would not be placing more structural fill than was necessary without witnessing it in a proof roll. I told him we needed to proofroll the native subgrade material first before we decided to place a truckload of structural fill in an area that is not needed. Mat was fine with this and Mat placed some material back in and compacted.

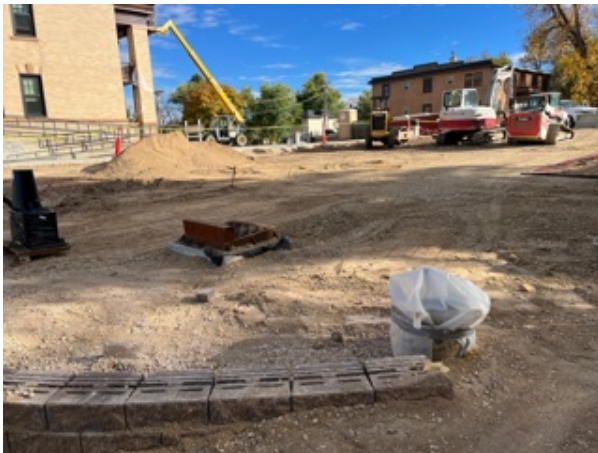
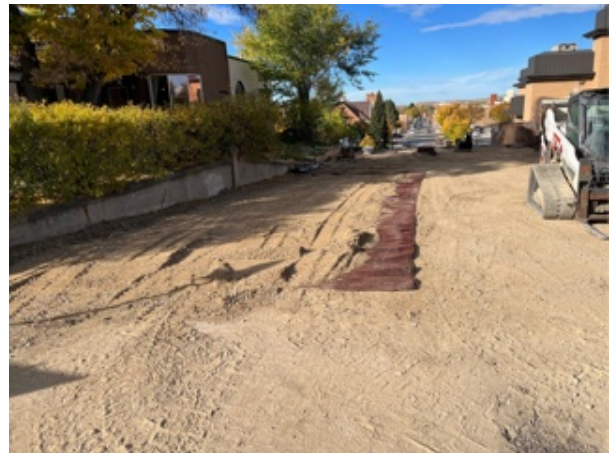
Arrived on site at 3:45. Northern Underground was not on site and no work was in progress. Northern Underground laid down about 60 feet of fabric under the curb line on the southwest end of Brook Street. Matt called me and informed me that Stone Mill will be pouring the curb on Tuesday of next week so they will be prepping the curb line the rest of this week and Monday.

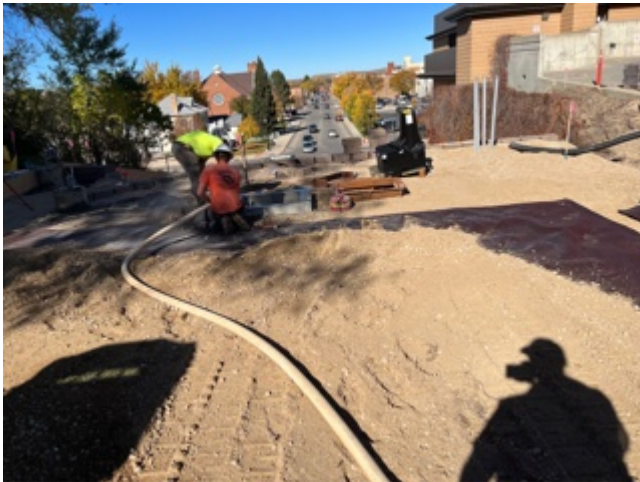
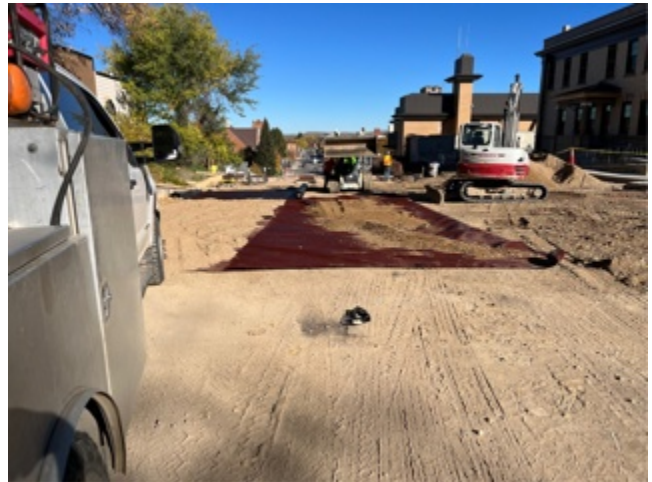
Arrived on site at two. Northern underground was on site with two laborers. They were in the process of cutting down the storm inlet box in the upper parking lot 6 inches. The laborers told me they had the wrong middle section sent to them and they did not catch it until they had already backfilled around. I did not have time to wait for a new middle section, so are just electing to trim the Inlet down 6 inches to make it fit.

Mike's electric was on site finishing the last of the lighted bollards and the light pole foundations.
