Daily Report

Sheridan County Brooks Street Greenspace

224 South Main Street
Sheridan, WY 82801
Job# : 6017.002.00

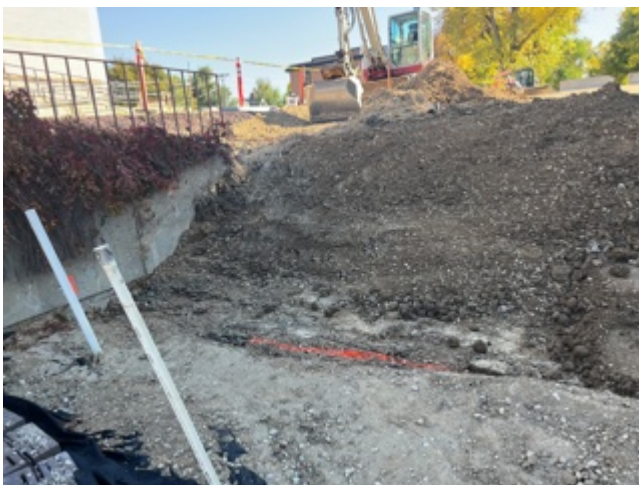
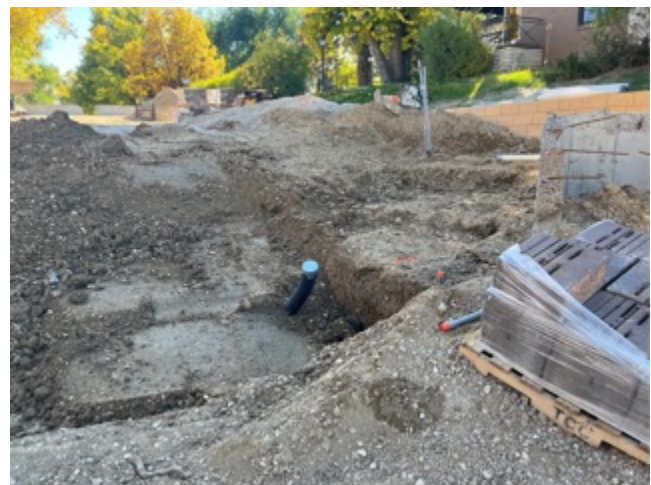
Arrived on site at 3:09. Northern Underground was on site with two laborers and I just finished working for the day. Today they exposed the subgrade for wall number 12 and prepped for the water service board and the juvenile justice building. Matt informed me Weston will be on site tomorrow to plumb up their materials on the other side of wall number 12 and once AET is out to inspect the subgrade for wall number 12 they will start building wall 12. Matt also informed me that Stone Mill is hoping to start pouring concrete on 19 October, he said that Swain will be at the weekly construction meeting tomorrow and will have a jointing plan for me.

Matt asked me about the east all that falls on the east side of the existing retaining wall, currently, the wall designer shows a 7 to 8 rows of block thickness buried where that would not necessarily be needed because of the existing retaining wall. Matt asked me if there was a way they could shorten that block row height to about 3 to 4 rows buried. I told him that we would not instruct him to deviate from the wall designer's plan. I did tell him it does not make much sense to bury that many rows of blocks in between that existing retaining wall and I would speak with Tim Brugger about that.

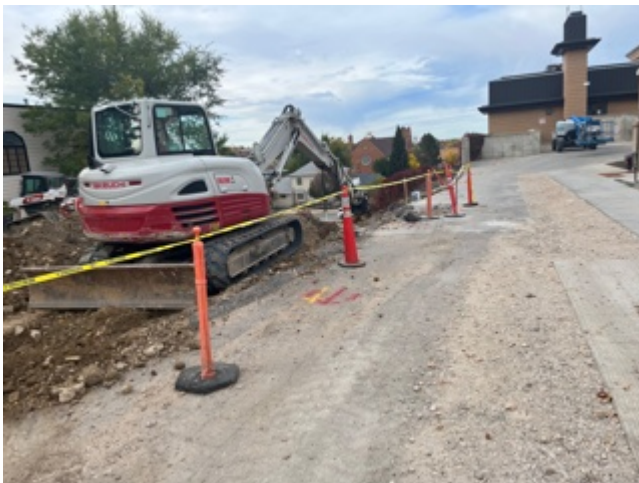
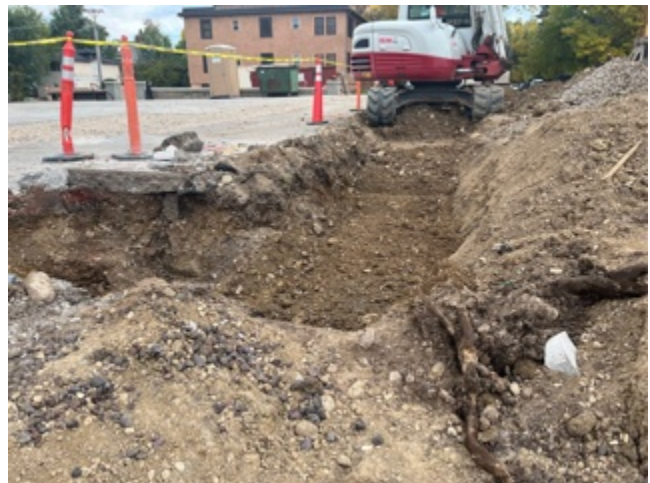
Arrived on site at 4:10. Road underground was on site with two laborers. They were in the process of backfilling the water service to the juvenile justice building. The operator that was backfilling and compacting was making sure to use small lifts (less than 1') of non-compacted material and was working around the old curb stop location. While he was compacting he was using approximately the amount of effort to achieve 95% compaction (compaction test needed to verify actual compaction). The material that was used to backfill had adequate moisture and was not too dry or over-saturated.

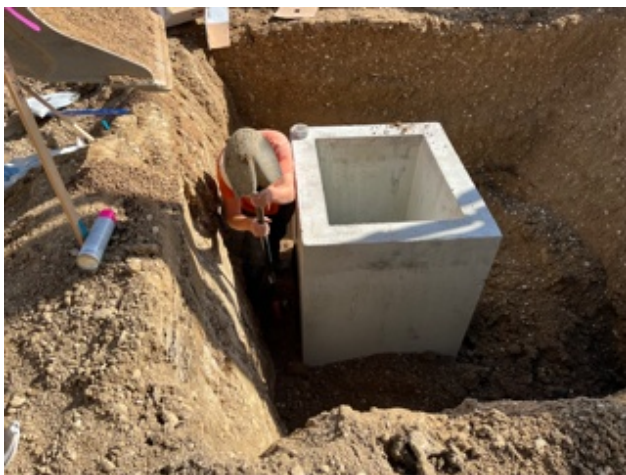
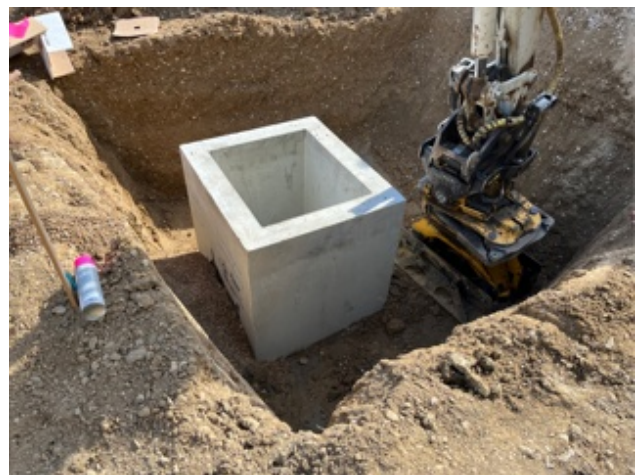
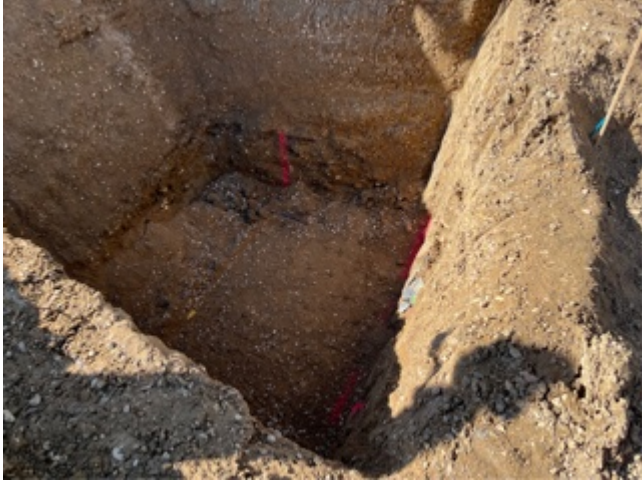
Arrived on site at 11:00. NU was on site with two laborers. The laborers were in the process of setting CI-4 in the upper parking lot. NU placed bedding below the structure to ensure that it was level and stable. Using the survey offset stakes and their GPS rover NU would double-check that they had the box in the correct location. After the box was set NU tied the storm line to the curb inlet box using a small piece of storm pipe. When NU placed the bedding around the small section of the storm pipe I asked that they make sure all of the bedding made it to the underside of the storm pipe so the storm pipe is adequately supported and will not sag in the future. NU used their shovel to pack the bedding to the bottom of the storm pipe and I asked NU to verify that the bottom of the pipe was supported by looking inside the inlet box and under the storm pipe.

The operator that was backfilling and compacting was making sure to use small lifts (less than 1') of non-compacted material and was working around the curb inlet box. While he was compacting he was using approximately the amount of effort to achieve 95% compaction (compaction test needed to verify actual compaction). The material that was used to backfill had adequate moisture and was not too dry or over-saturated.

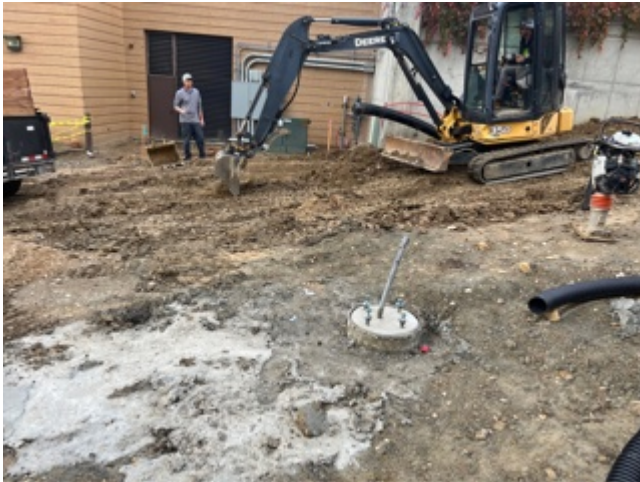
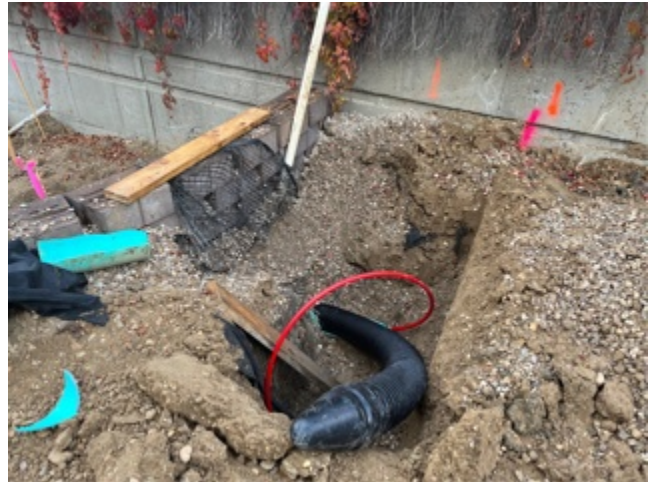
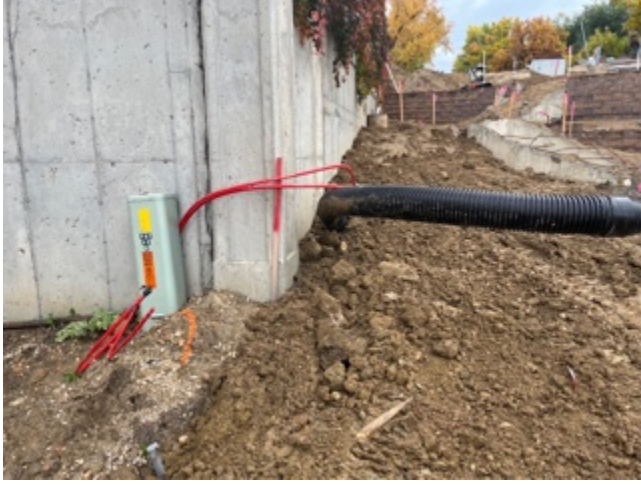
Arrived on site at 4:00. Westing Mechanical was on site with two laborers. Westin was in the process of placing the Insulpex two-pipe system with the red reader pipe. Westin used the sleeves provided by NU to stub those systems under the retaining walls. Westin did not backfill any of the pipes that they placed while I was on site.
