Daily Report

Sheridan County Brooks Street Greenspace

224 South Main Street
Sheridan, WY 82801
Job# : 6017.002.00

RETAINING WALL CONSTRUCTION

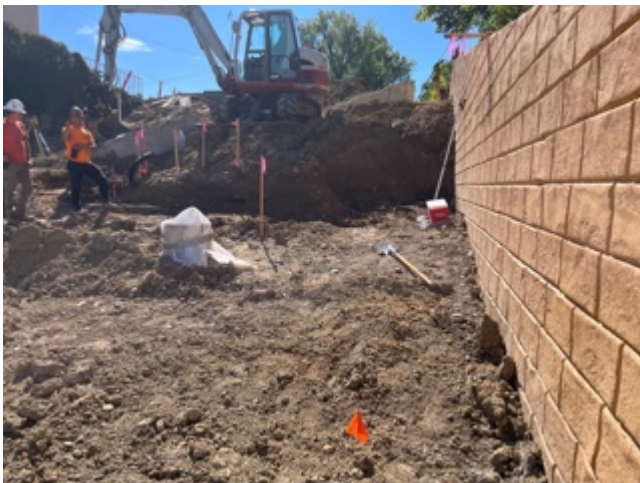
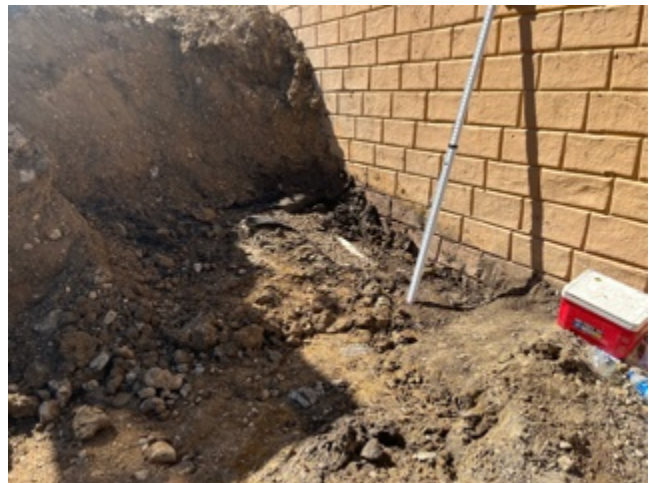
Arrived on site at 11:33. Northern Underground was on site with two laborers. The laborers are in the process of exposing the subgrade for wall number seven. Northern Underground had exposed 5 to 6 inches below the bottom of the wall elevations for roughly the whole wall. In one section, they started to expose the French drain for the soldier pile retaining wall that the block wall will sit against. I asked them if they thought this would be a problem, and they did not think it would be as the top of the French drain is 5 1/2 inches from the bottom of the wall. Matt said they would reinstall some fabric over the top of the pipe so as to not affect the French drain system.

Matt informed me that their surveying was off, so they were pretty much at a standstill for the rest of the day until Arrow came out and fixed the mistakes. The surveyor did not sit their antenna height correctly so all of their elevations were wrong. I told Matt that AET should be out tomorrow morning and would let him know the exact time that Colter could be on site to inspect the subgrade. I informed Matt that I'll be working through quantities to get them a payout for this month.

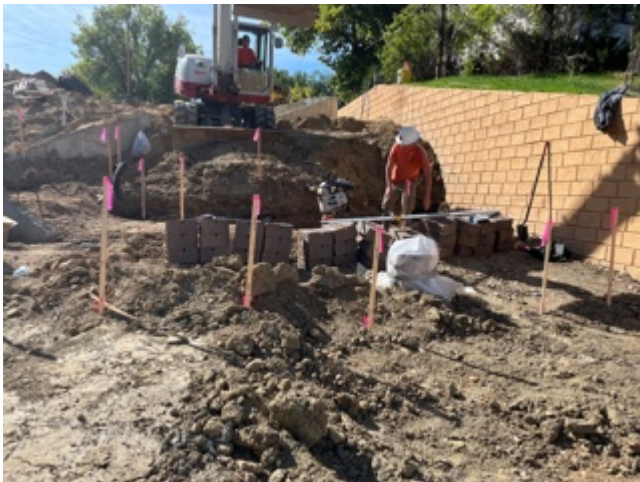
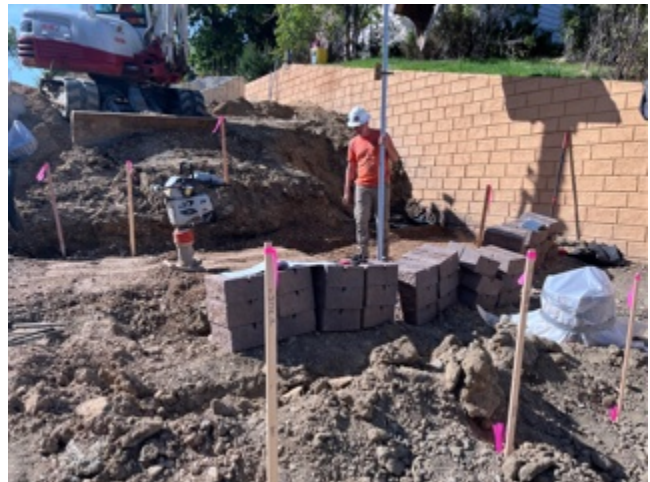
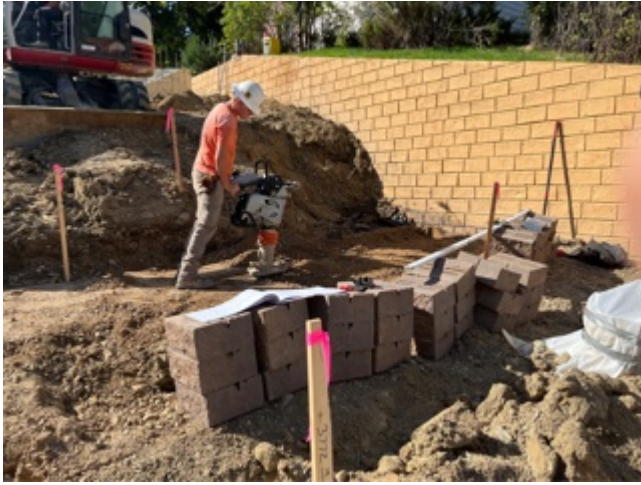
Arrived on site at 10:50. Northern underground was on site with two laborers. While on site NU was leveling out the base of the retaining wall using the grading W that the wall designer had called out. One laborer was using a jumping jack compactor to ensure the material was tightly packed. Mat asked me if I had a problem with them using a small amount of dirty pea gravel as a leveling course. I first told Mat that he needed to reach out to the wall designer and check with him. Mat indicated that the wall designer has not been responding to NU's calls and emails. I told Mat that there should be no problem with this as they plan on placing less than 1/4" of material but that we would not approve since it is not our design. They are currently placing the first block row for wall number seven. Northern Underground is taking its time to ensure that the blocks are flush and level so the wall comes out straight. Northern Underground was checking every so often on their ten-foot offset survey markers to ensure the blocks were in the correct location.

I made sure that Mat had the geogrid on site to place in between this block layer and the next blocks and he indicated to me that he did and will once the first row of blocks is complete.

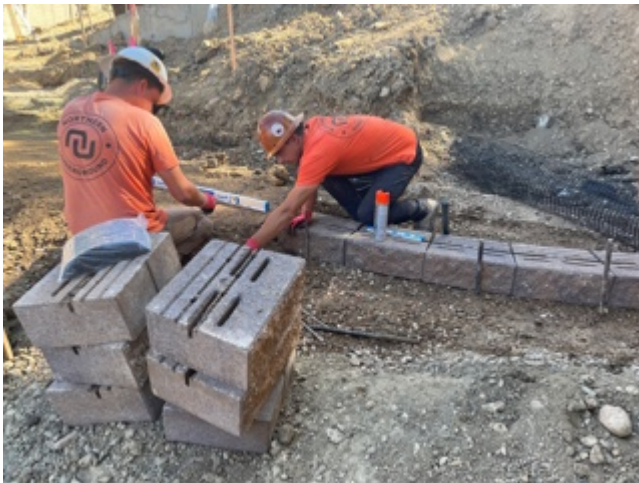
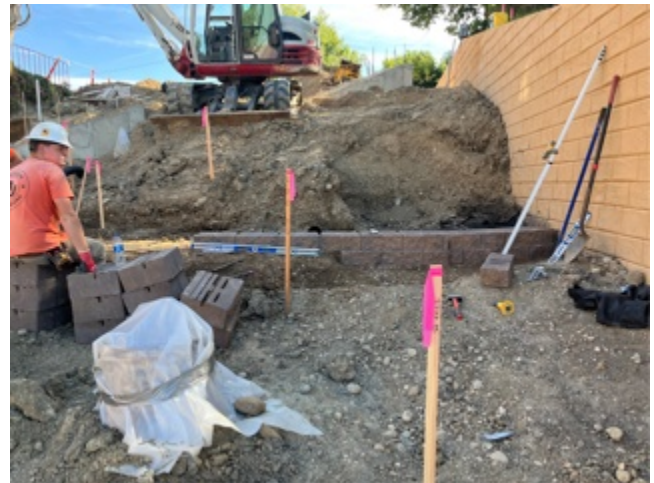
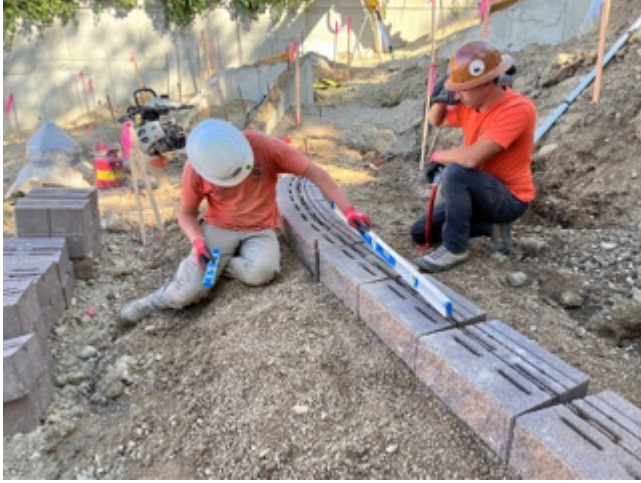
Arrived on site at 3:30. Northern underground was on site with two laborers. They have about two block rows placed for wall number seven. On the western side of the wall, they place the Geo grid where the wall is now two blocks high. The geogrid was placed in between block row number one and row number two. As they get closer to the stairwell on the eastern side the wall will tie into the block wall is only one block high, so the geogrid will be placed on the top of that block prior to the placement of block row two. Northern Underground is taking its time to ensure that the blocks are flush and level so the wall comes out straight. Northern Underground was checking every so often on their tent for the offsite survey markers to ensure the blocks were in the correct location.

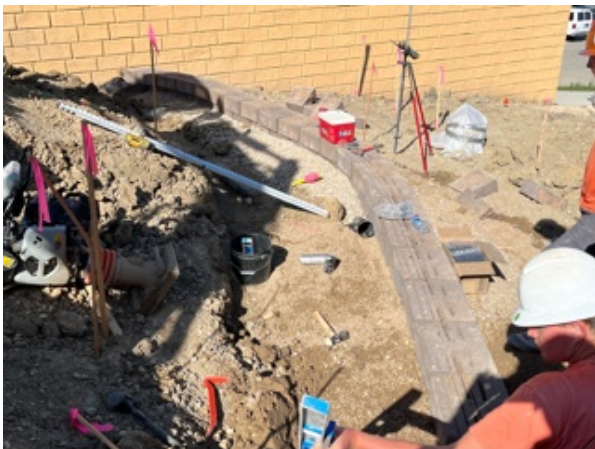
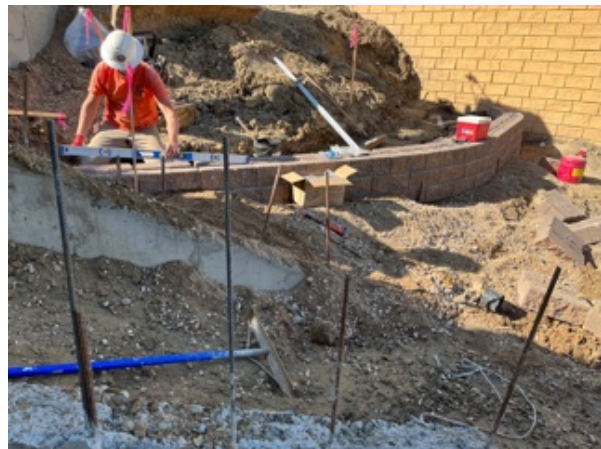
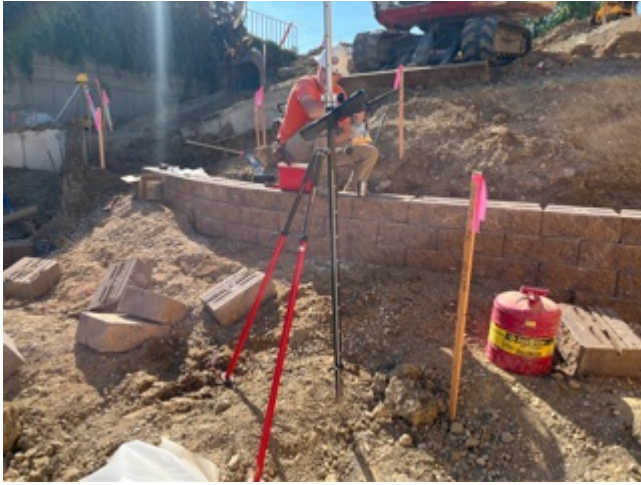
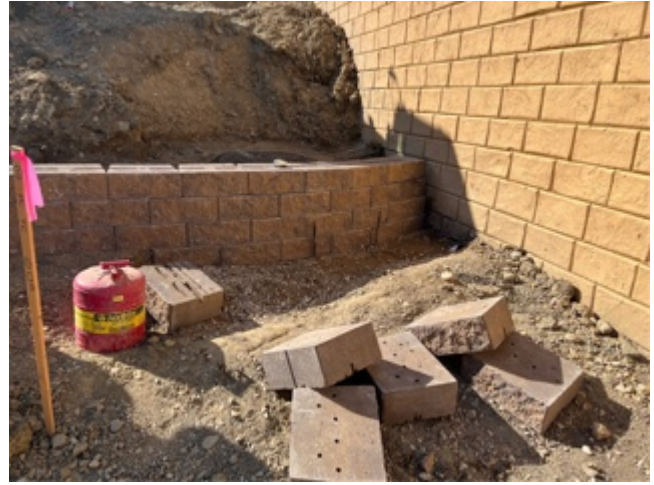
Northern Underground has almost finished placing wall number seven. There have been no issues with the placement of this wall. Northern Underground is using plastic pins to secure the blocks to the bottom layer, the Geo grid at specified heights for the block, and installed the French drain system with rock behind the deeper parts of the wall. The French drain system behind wall number seven is about 50% complete.

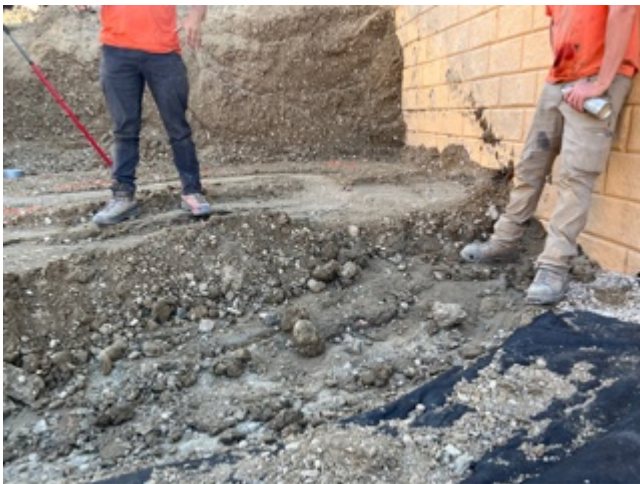
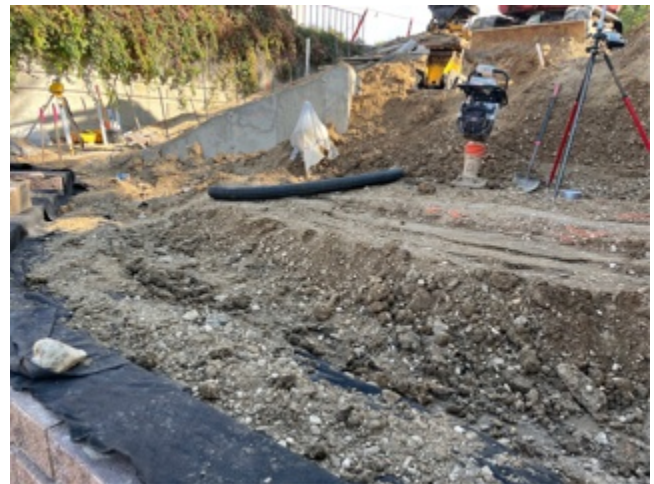
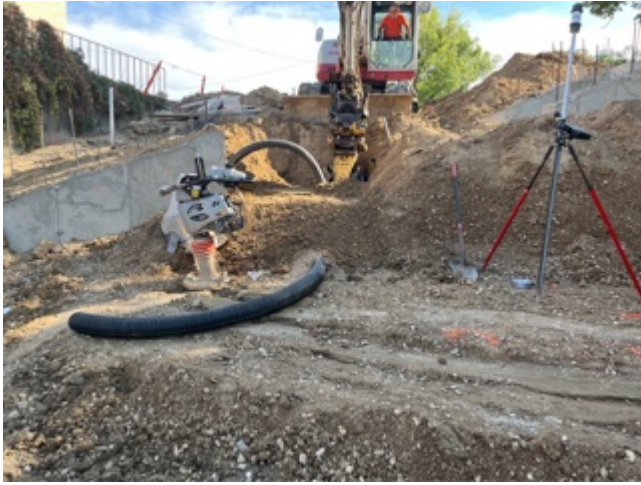
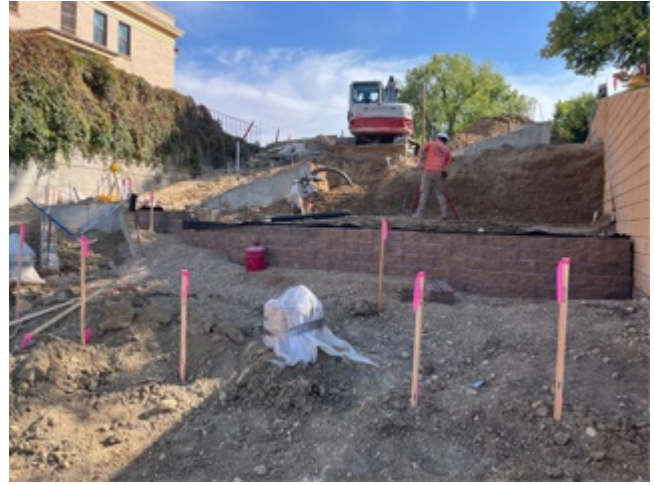
Arrived on site at 3:45. Underground was on site with two laborers. Colter Carzoli with AET showed up on-site at four. Northern underground had been exposed to the subgrade elevation for wall number nine and had to pass the test for the fill material that was now the subgrade. Colter examined the subgrade and had no issues with the material. Northern Underground plans to start laying blocks tomorrow after they get 6 inches of grading W placed above the subgrade and compaction test.

Before Colter showed up on-site to inspect the subgrade, Northern Underground was backfilling around one of the poly pipes that is tied into the storm drain system. This poly pipe will carry the flow from the French drain of the block retaining walls into the storm drain. To backfill around the poly pipe, Northern was using a vibrating plate compactor on the excavator. There were no issues with Northern's backfilling process as they were using relatively small lifts

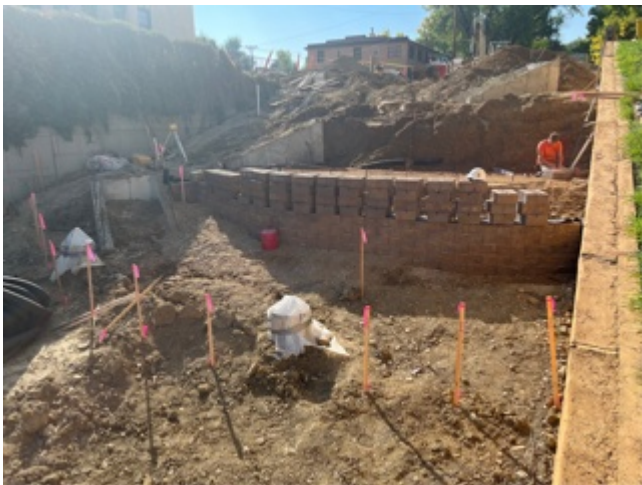
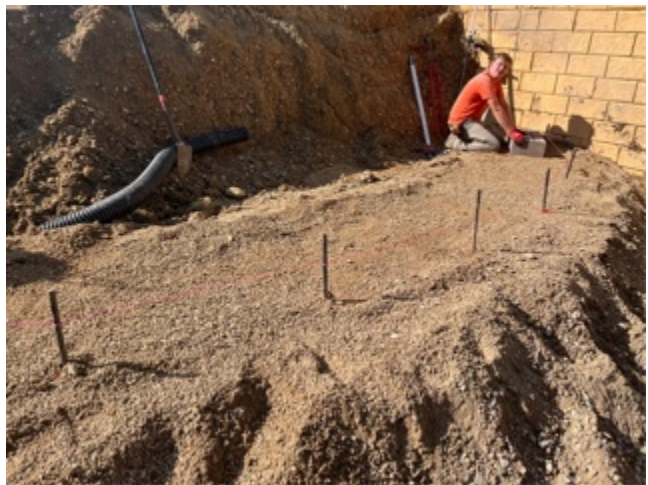
Arrived on site at 10. Northern underground was on site with two laborers. They were in the process of placing the first row of the block for retaining wall number nine. The labor was about halfway done with the first row. The other labor was placing the irrigation sleeve under retaining wall number nine. He placed a 5 foot chunk of 2-inch PVC pipe in the base layer of the retaining wall. He then shot the irrigation sleeve with his GPS station to record the location for later use. Their process for setting the blocks was acceptable. Northern Underground would use a small layer of pea gravel as a leveling course on top of 6 inches of grading W that was used for the base of the wall. The base of the wall received a compaction test today at nine and Matt informed me the two tests passed with adequate compaction and moisture. After placing the thin layer of leveling course (pea gravel) Northern Underground used levels to flatten the P gravel, place the block on top, and use levels on top of the block to ensure it was flat and level in all directions. They did this with all of the Blocks they placed while I was on site.
